Report of the Task Force on American Iron & Metal Operations and September 14, 2023 Fire

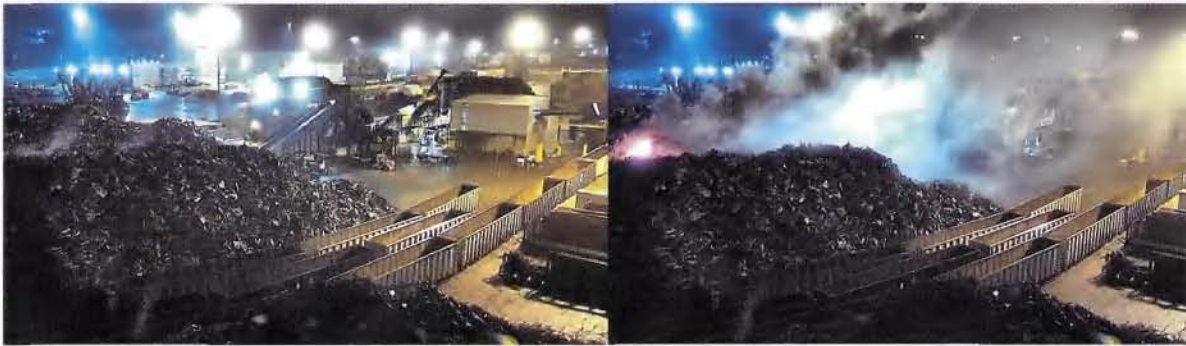
Video footage shows that, within 15 minutes of the appearance of smoke, a major fire broke out:

Thurs. Sept 14th, 1:18a.m. and 1:33a.m. -- Smoke quickly progresses to major fire.

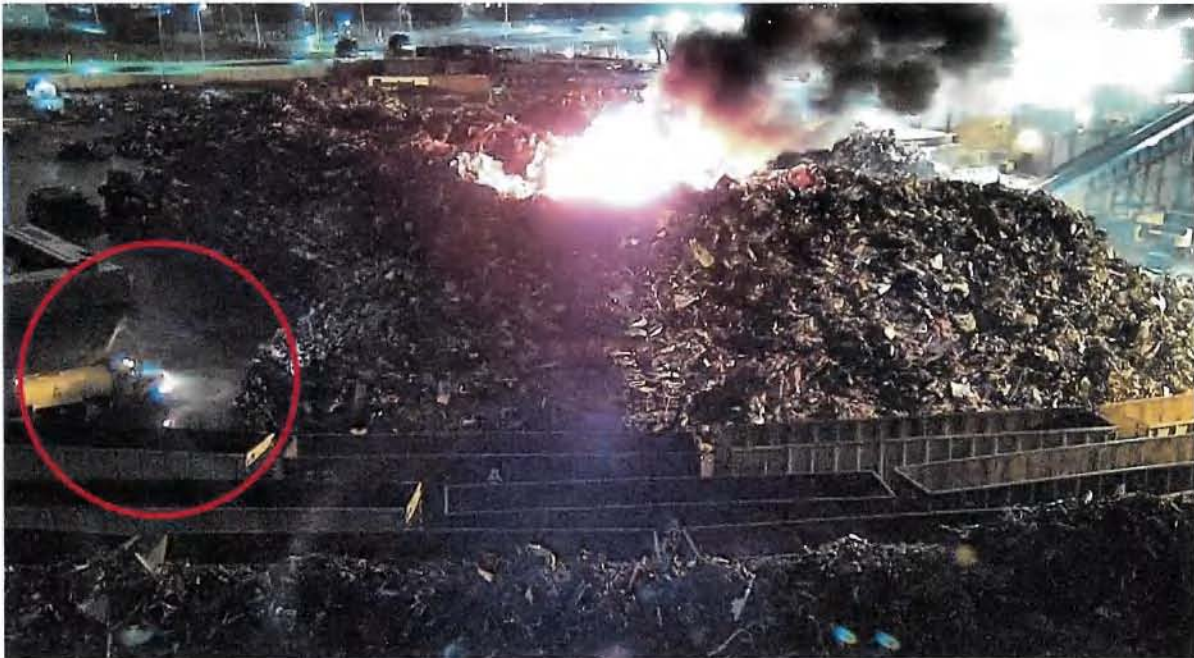
At 1:33 a.m., AIM dispatched its own water truck. An AIM employee called 911 at 1:38 a.m.¹⁵ The AIM water truck was entirely incapable of providing any effective mitigating response to the fire because of the massive size of the pre-shred pile. The water stream of the AIM truck had a reach of approximately 20 feet,¹⁶ which was not even sufficient to reach the perimeter of the pile, much less the fire:

Sept. 14th, 1:42a.m. - AIM water truck ineffective at reaching flames.

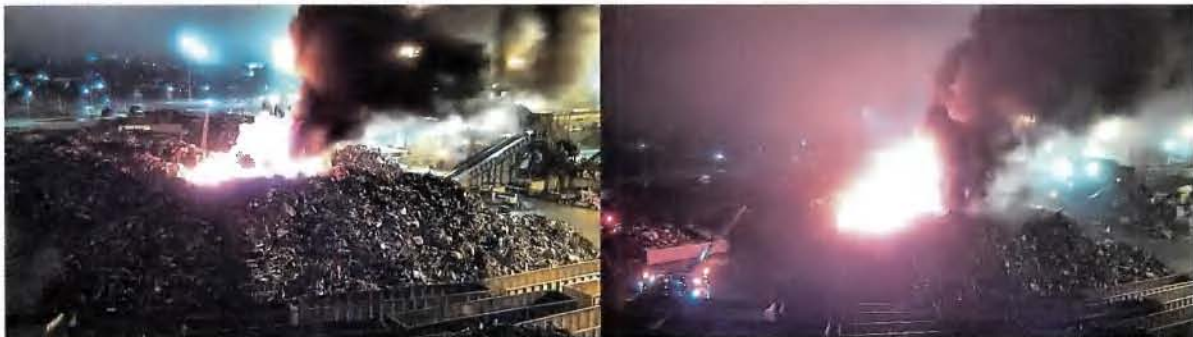
Thurs. Sept 14th, 2:04a.m. and 2:34a.m. - 30 minutes of SJFD firefighting activity from fire ladder as flames worsen.

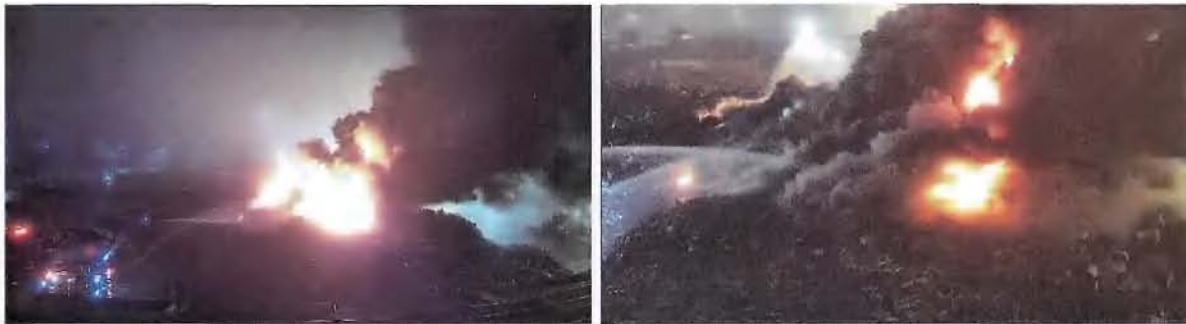
Because the AIM fire hydrants on site were only sufficient to support three firetrucks, subsequent firetrucks connected to City of Saint John hydrants in the nearby residential area. By 3:00 a.m., the situation was worsening and the SJFD was advised that it would not be able to continue to draw water at its current rate without depleting the water supply of the City's west side to critical levels. Emergency responders began identifying a plan for an alternate water source.

**Sept. 14th, approx. 2:50a.m. :
Fire grows uncontrollably despite efforts of 2 ladder trucks and 1 ground line**

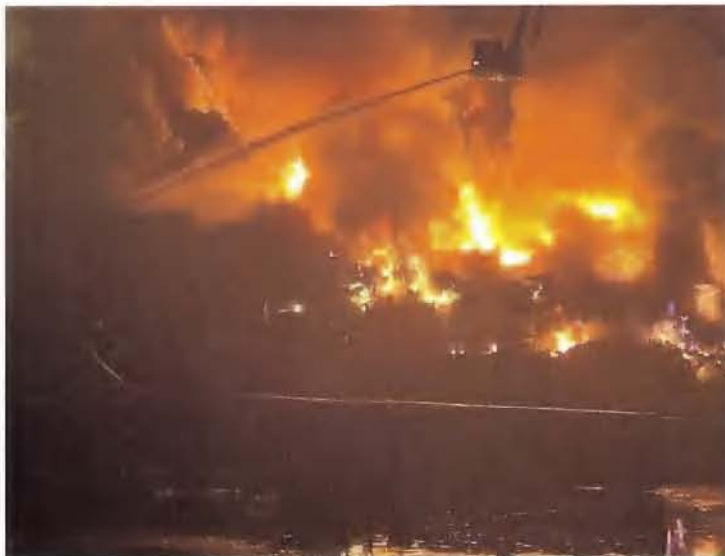
By 4:35 a.m., an effective alternate water source was urgently being sought and the blaze was completely out of control. The size and location of the pile made it extremely difficult to effectively position firefighting resources to fight the fire. Black smoke and dense fog severely reduced visibility. Explosions and flying projectiles from the fire pile made it increasingly unsafe for firefighters, requiring equipment to be pulled back from the perimeter. While emergency responders on scene were advised to wear breathing apparatuses for their own health and safety, it was impractical for firefighters to wear self-contained breathing apparatuses for the entire duration of the fire. The SJFD was and is simply not equipped or resourced to combat a dangerous industrial fire of this size and scale at such a site.

Thurs., Sept. 14th, 4:35a.m. - Fire burns at AIM Site.

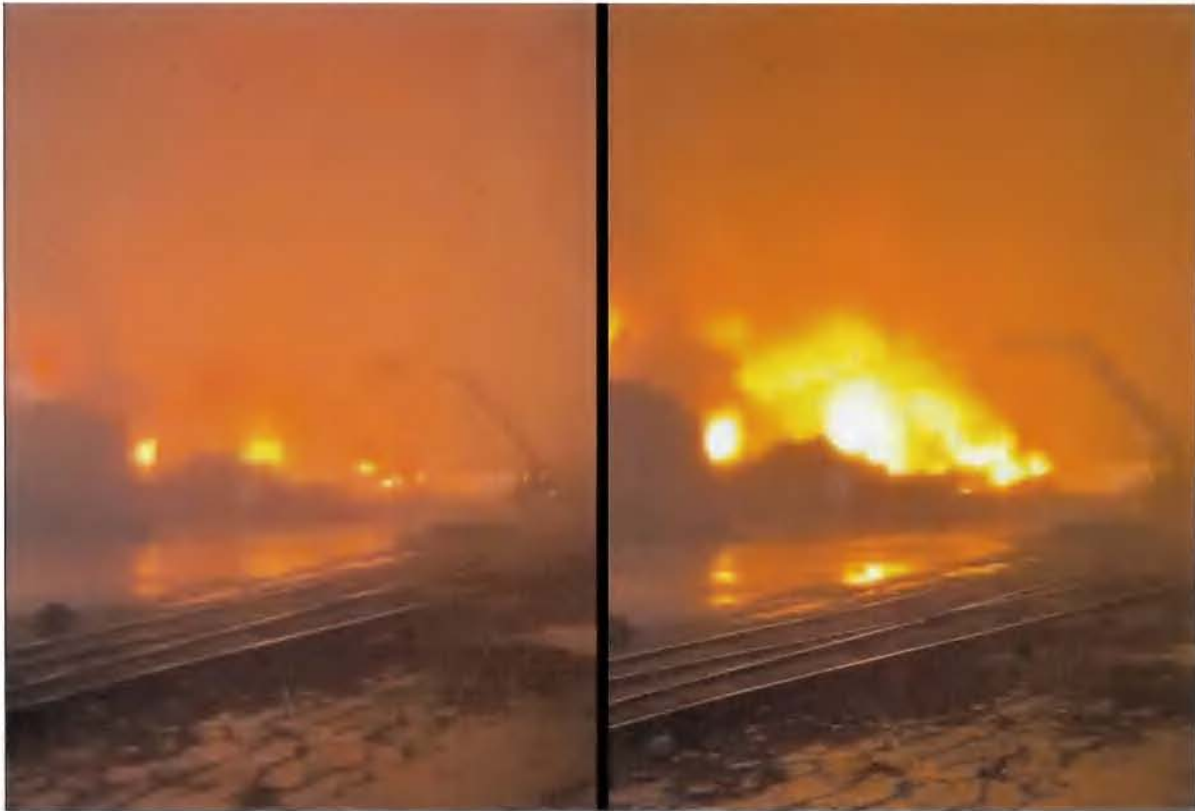
Thurs. Sept. 14th, 6:14a.m. - Moments before and after explosion occurs on AIM Site as SJFD work to combat the fire.

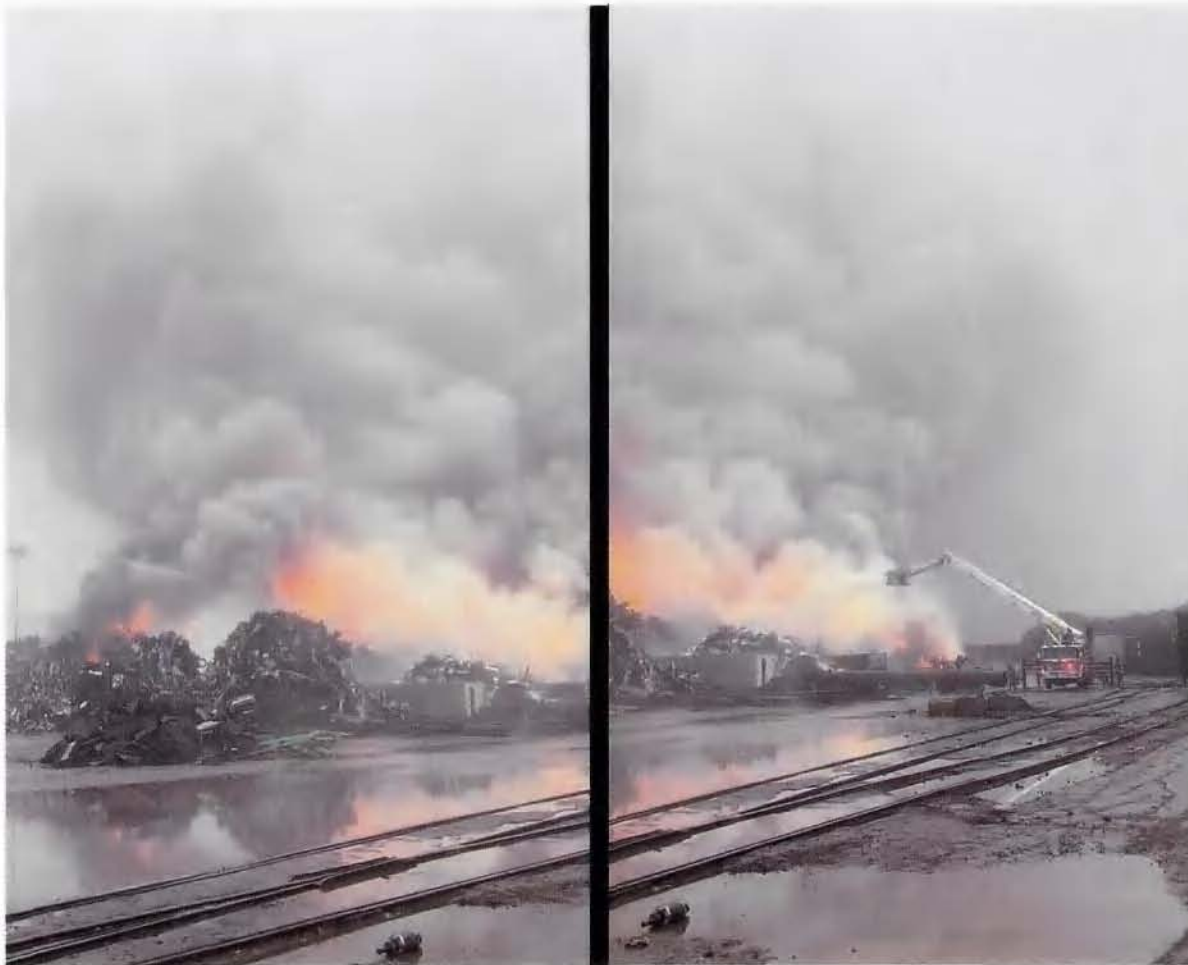
Thurs, Sept. 14th, 7:43a.m. - SJFD works to combat fire at AIM Site.

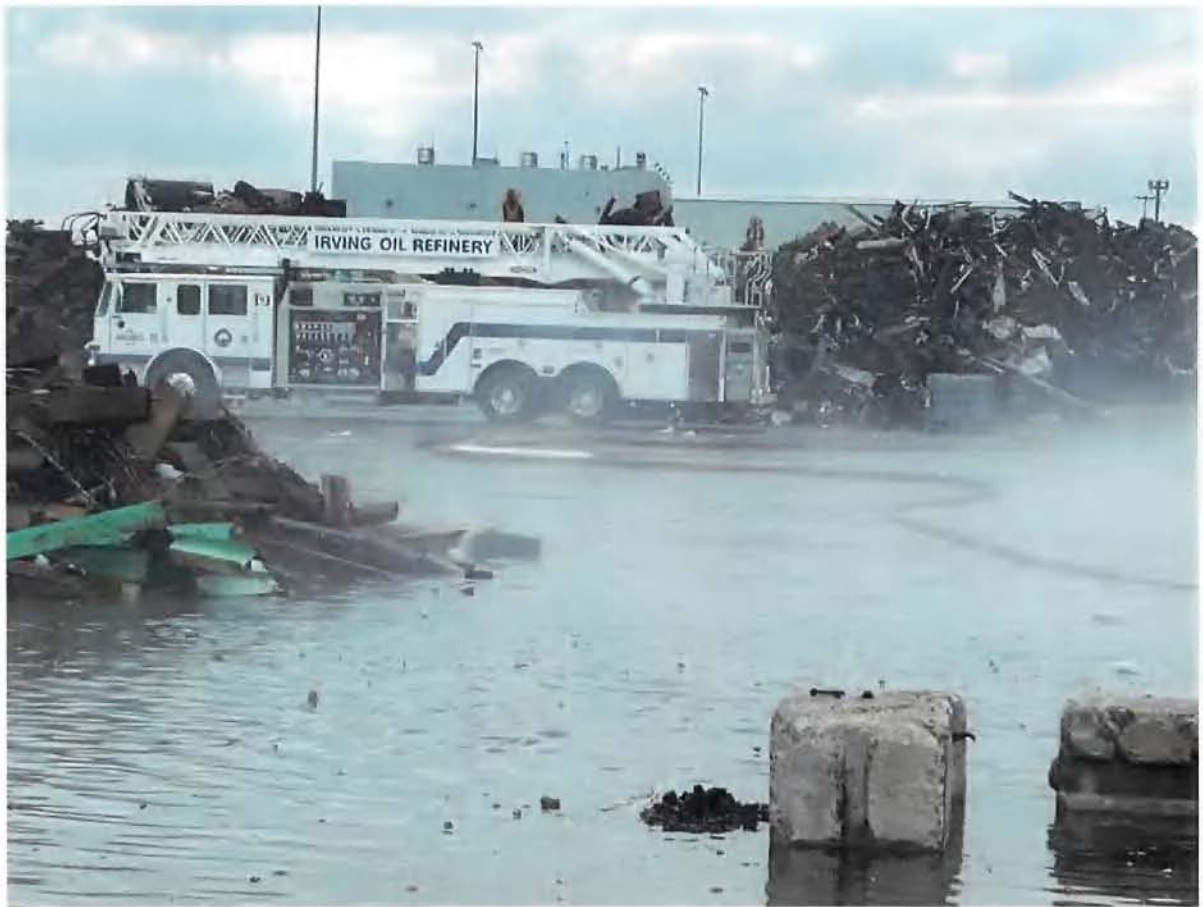
Thurs., Sept. 14th, 2:39p.m. - Irving Oil on AIM Site providing assistance to SJFD.

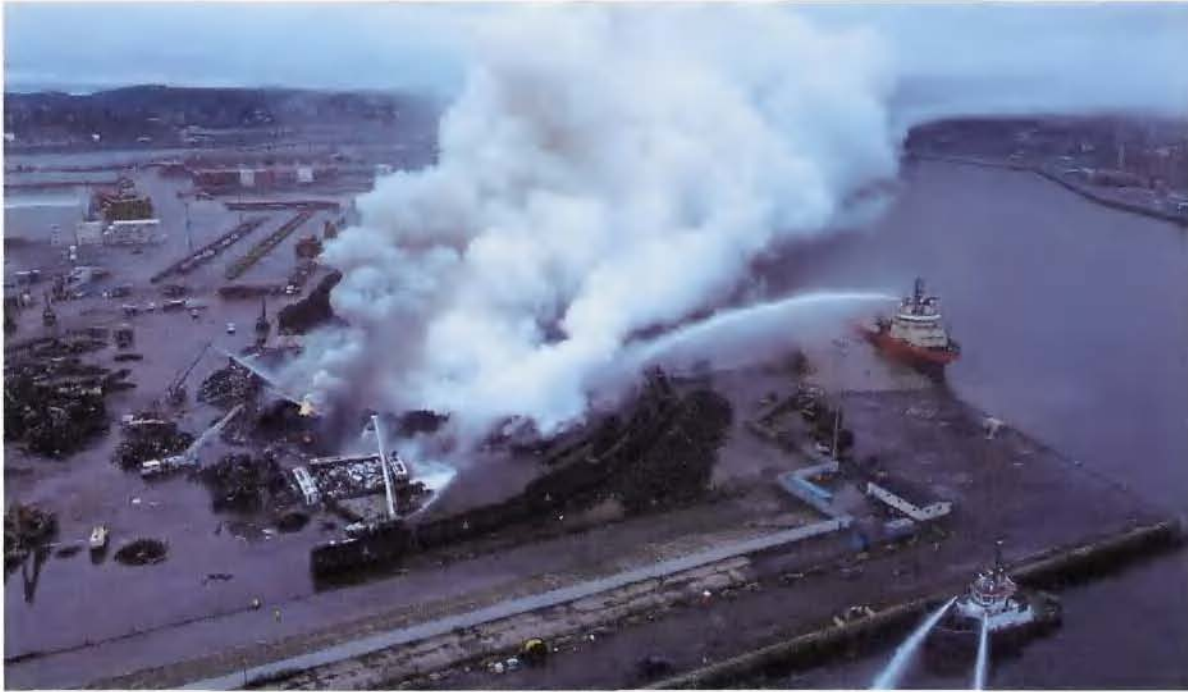
Sept. 14th, approx. 1:06p.m. - Efforts to fight the AIM Site fire include three SJFD trucks, other SJFD equipment, an Irving Oil truck, the Atlantic Osprey, and the Spitfire III.

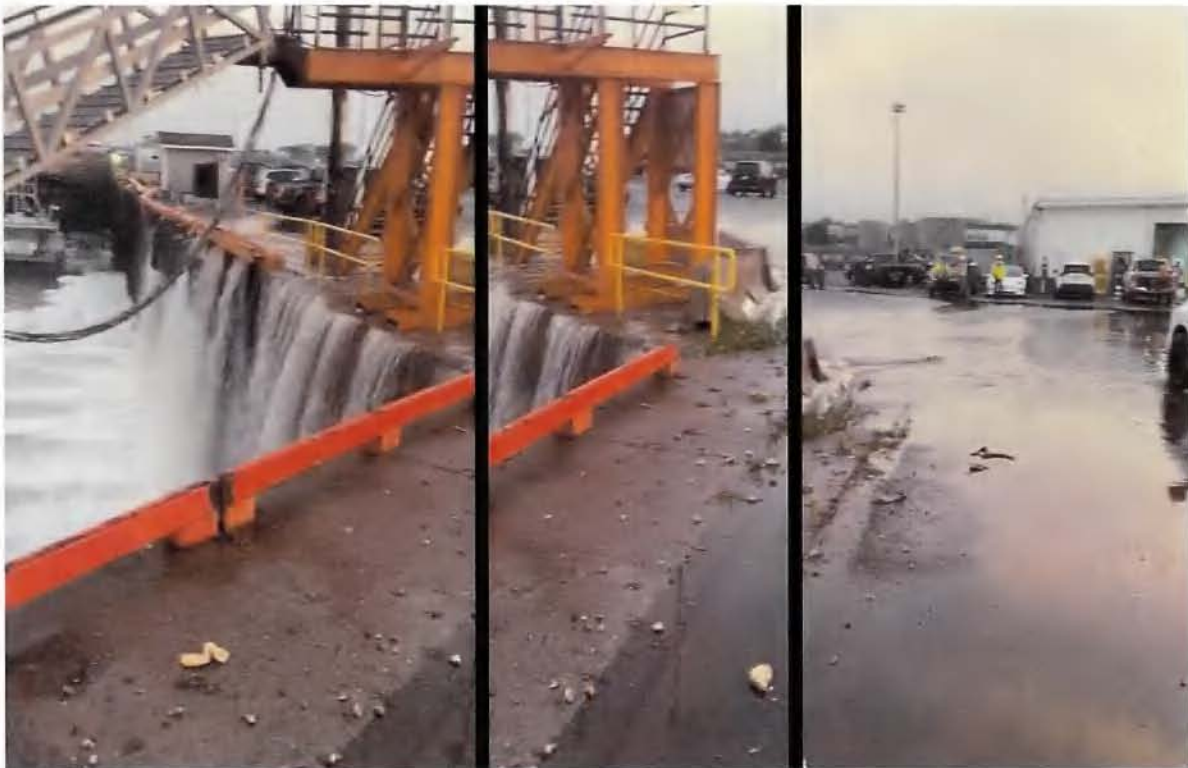
22 million gallons used to combat fire at AIM Site running into harbour.

The surrounding area flooded, with floating propane tanks, a gas tank and other hazardous debris from the site littering the area.

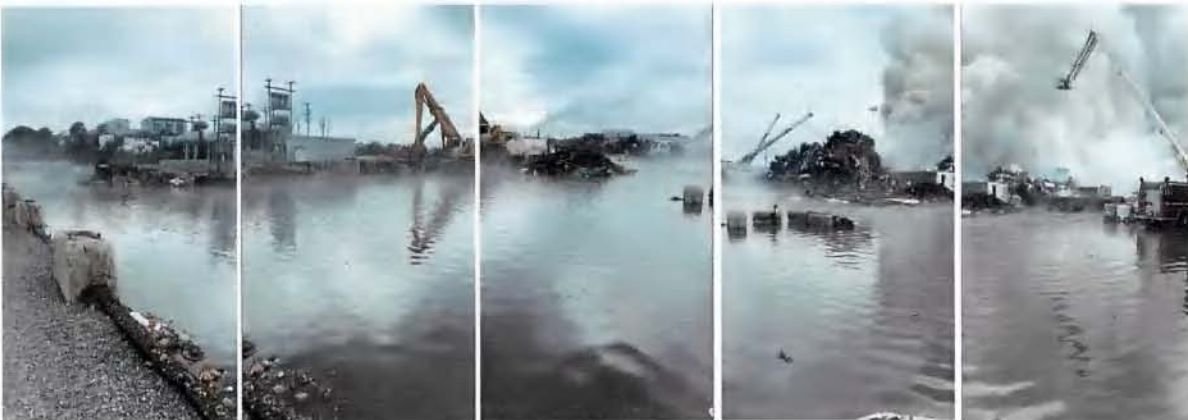
Thurs., Sept 14th, 2:41p.m. - 22M gallons of standing water at AIM site destined to run into harbour.

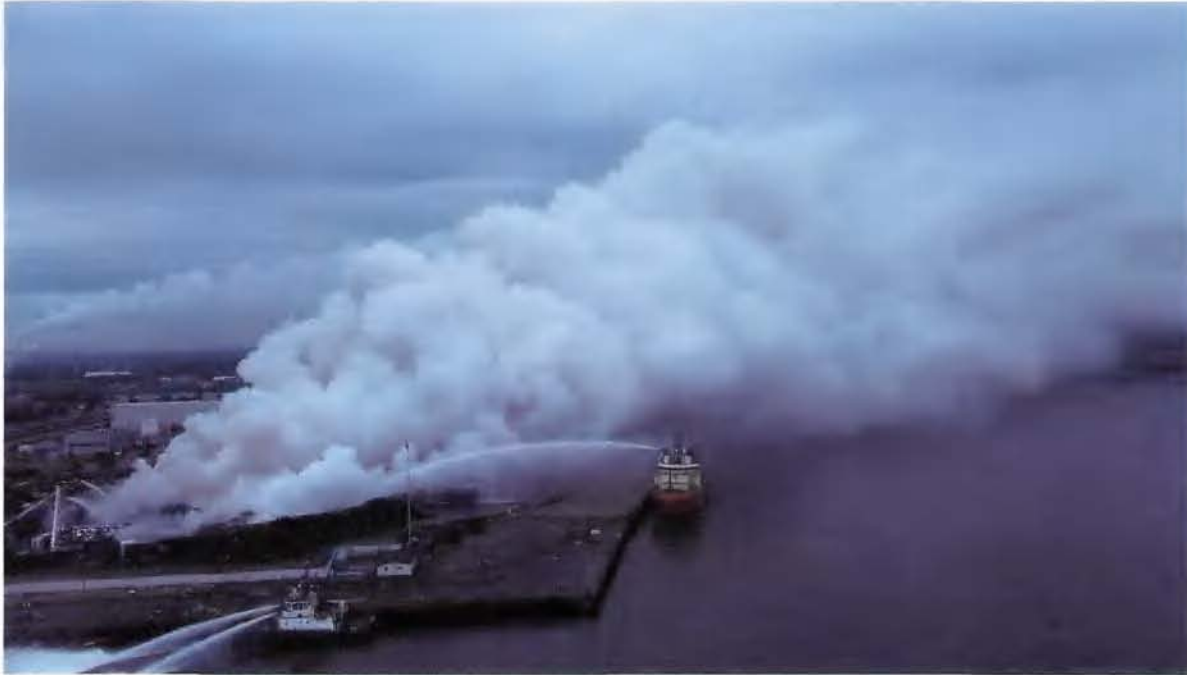
Sept. 14th, approx. 1:06p.m. - Dense smoke from AIM fire flows into city center.

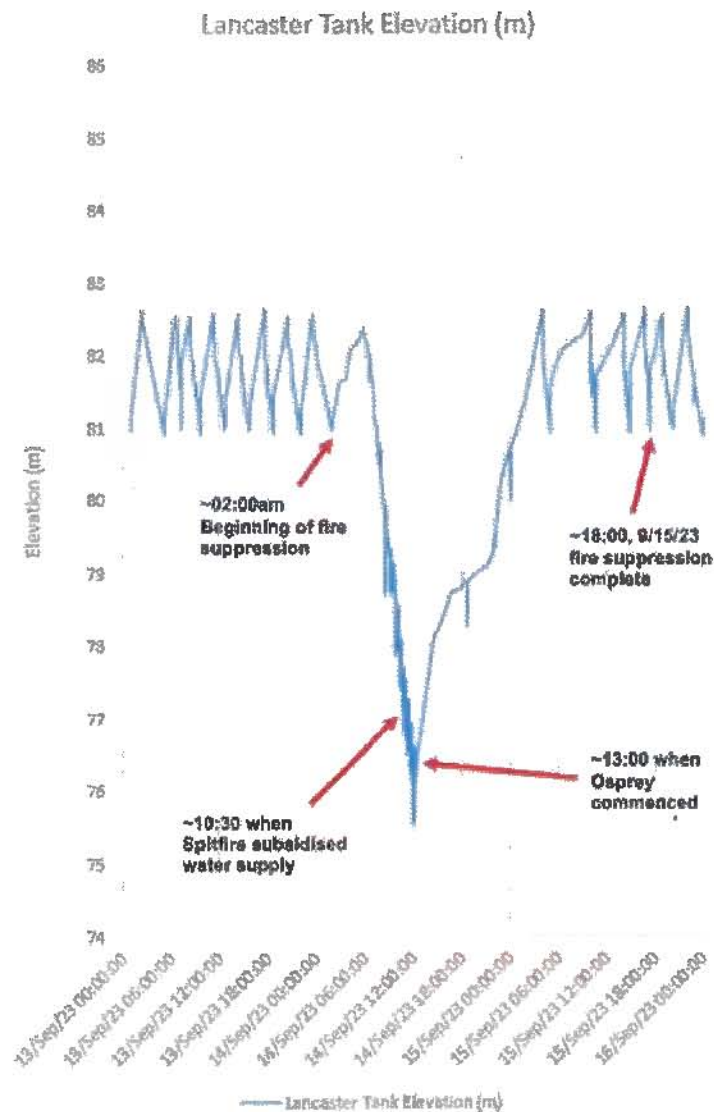
Figure 7 in the Arcon report,⁴⁷ copied below, shows the beginning of the firefighting efforts and the substantial dip in the reservoir levels as the firefighting efforts continued. The draw down in the reservoir was only alleviated as a direct result of the Osprey's assistance.

Arcon determined that the Lancaster reservoir was drained of almost half its capacity during the first 6 hours of firefighting efforts, and could not have been maintained for more than an additional six hours without critically affecting the water supply to the West Side of Saint John.⁴⁸

Arcon concluded that the likelihood of future fire events at the AIM facility is high.⁵⁰ Given that the size of pre-shred piles exceeds engineering recommendations and that the capacity of the existing water service of the City of Saint John is insufficient to combat a similar fire in the future, Arcon concluded that it would be necessary to substantially reduce the size of the scrap piles and the amount of combustible material contained in a pile, and to substantially increase the available supply of water⁵¹ for fire suppression purposes.

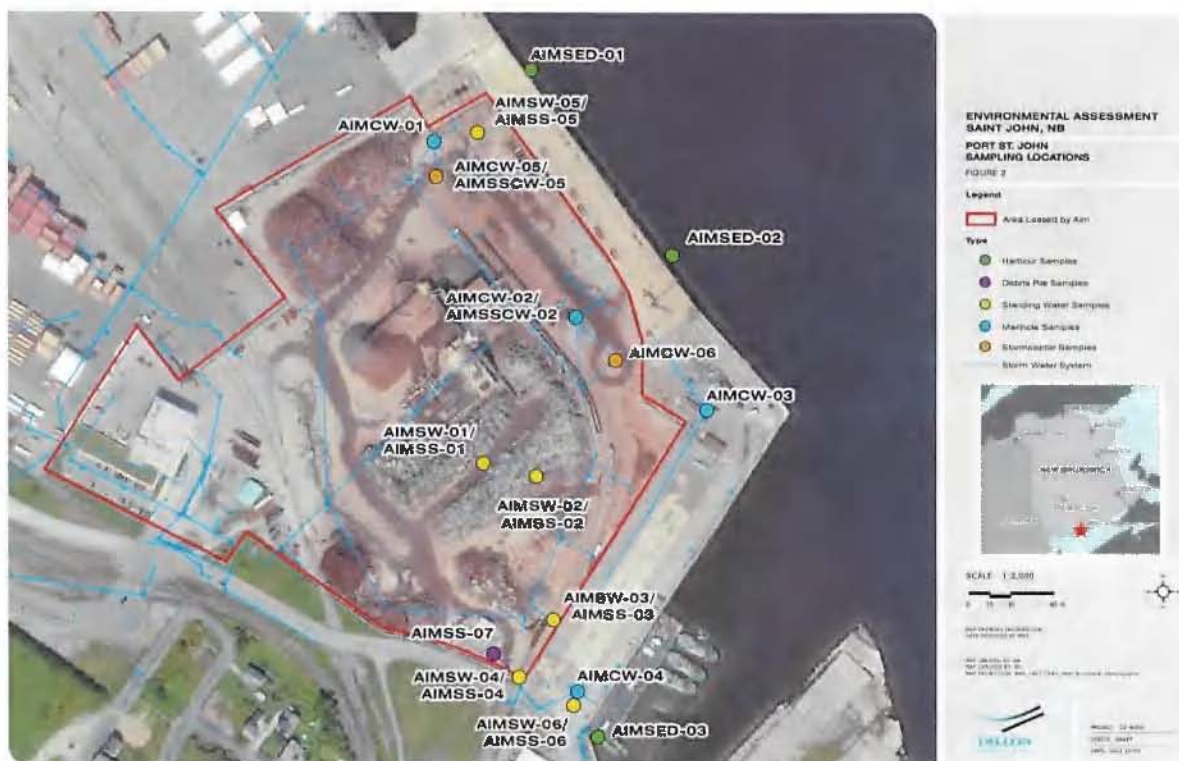
Dillon tested soils, surface water and in catch basins and stormceptors at the AIM site for contaminants. Figure 2 shows the Sampling Locations.⁵⁴

Testing was completed for various metals that can be harmful to human health and found metals present at levels which exceed human health criteria by up to 18 times the allowable levels, and ecological health criteria by up to over 1,890 times allowable levels. Examples of excess metal contaminants are set out below:
