Report of the Task Force on American Iron & Metal Operations and September 14, 2023 Fire

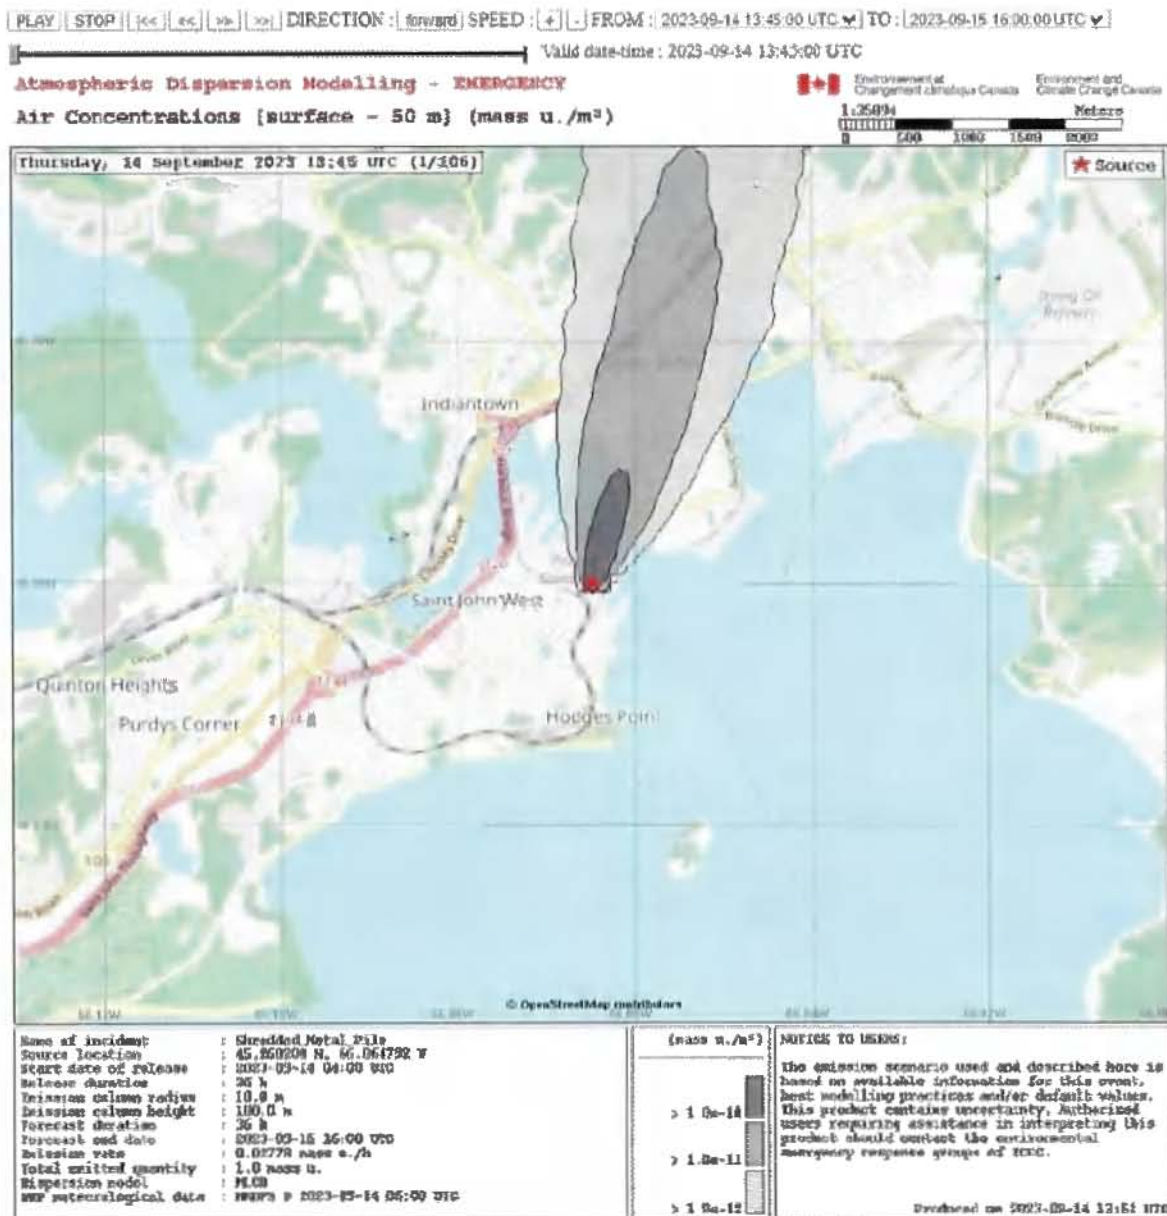
60

On September 14 and 15, 2023, there was a significant visible plume of smoke coming from the fire. The smoke contained soot, ash and likely other contaminants. The plume travelled to the northwest covering the southern peninsula of Saint John and travelling generally in the direction of the Kennebecasis Valley towards Rothesay.

The smoke plume would inevitably land at locations in the region, carrying with it soot, ash and other contaminants. Dillon performed testing at several community gardens in the Saint John area. One community garden, located in the southern peninsula, contained elevated levels of lead. Dillon was unable to conclude where the smoke plume would have landed and deposited various contaminants without further extensive testing and analysis. It recommends additional environmental testing and atmospheric modeling to determine the locations at which the plume likely made land fall.⁵⁹
